SUMMIT Laser Products

Remanufacturing the Samsung SF-830 Drum Cartridge

First released in February 2002, the Samsung SF-830 is a 12ppm fax engine that runs at 600 dpi. The Samsung drum cartridge SCX-5312R2 is rated for 15,000 pages. These drum units are very similar in function to the Sharp AL-1000 in that they have a long plastic auger that moves the waste toner along into a small cavity at the end which in turn dumps into the waste chamber on the toner cartridge. As with the AL-1000 drum units. These cartridges are very simple to remanufacture.

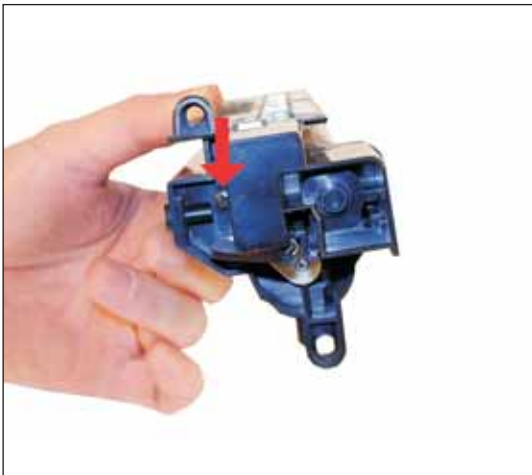
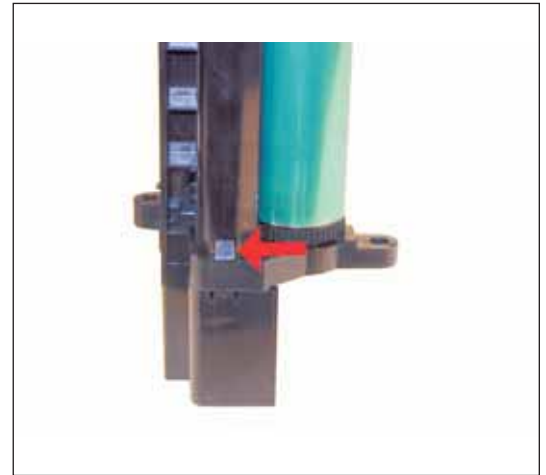
- 1) Remove the screw located on the waste chamber. Press in on the tab, and remove the waste chamber. See Figure's 1 & 2

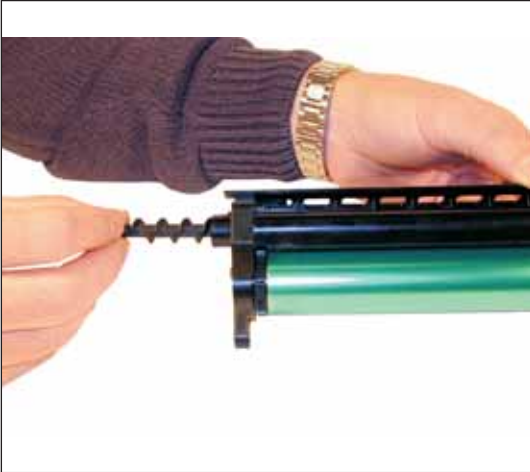
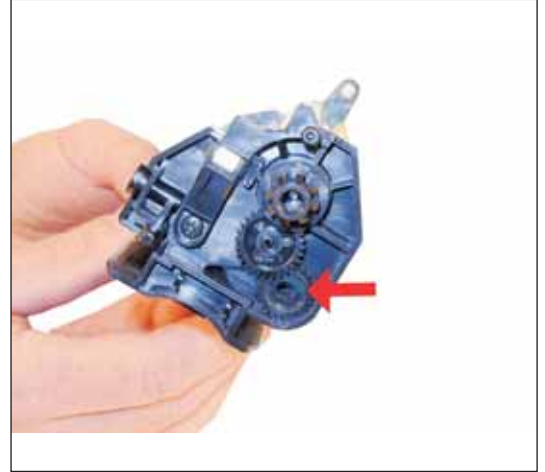
2) Remove the waste auger from the cartridge. The augers drive gear will come loose at this point. Remove the gear, and place aside. (The gear is on the opposite side of the cartridge). See Figure's 3 & 4

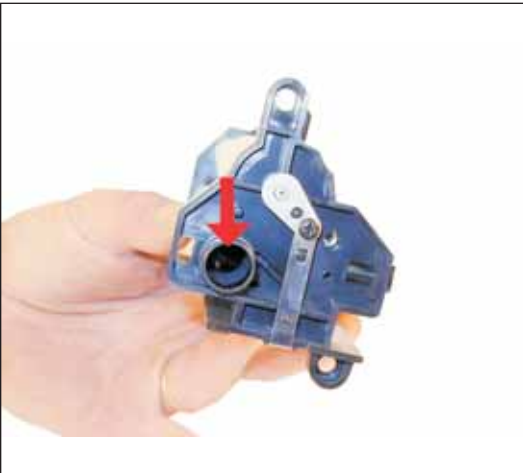
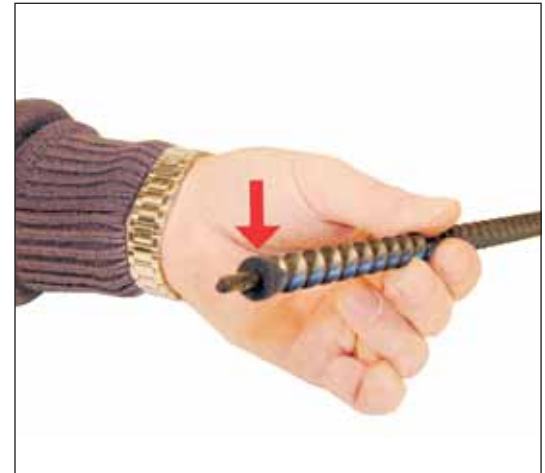
3) Vacuum the auger and foam seal clean. Vacuum/dump out any remaining bulk toner on the auger's chamber. See Figure's 5 & 6

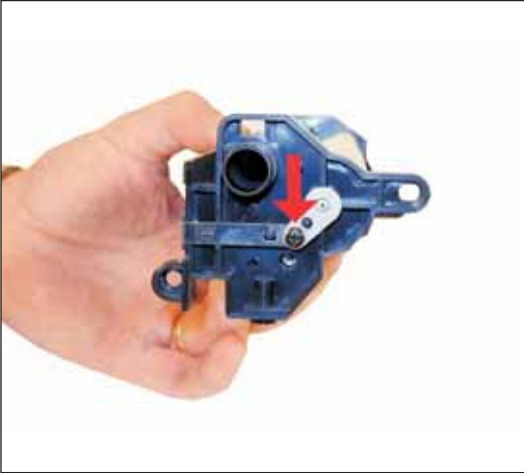
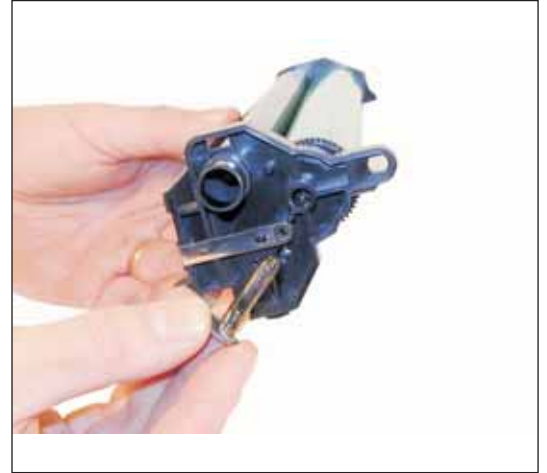
4) Remove the screw on the drum axle, and the drum axle pin. See Figure's 7 & 8

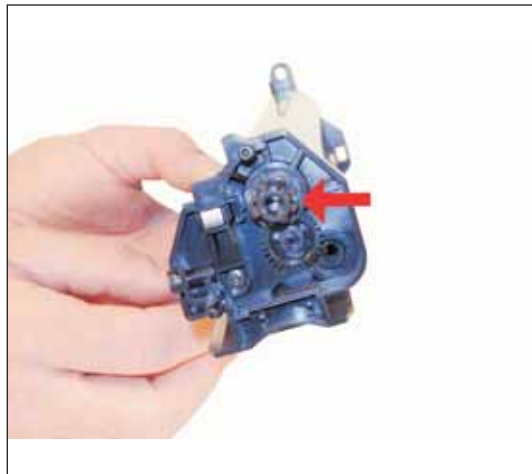
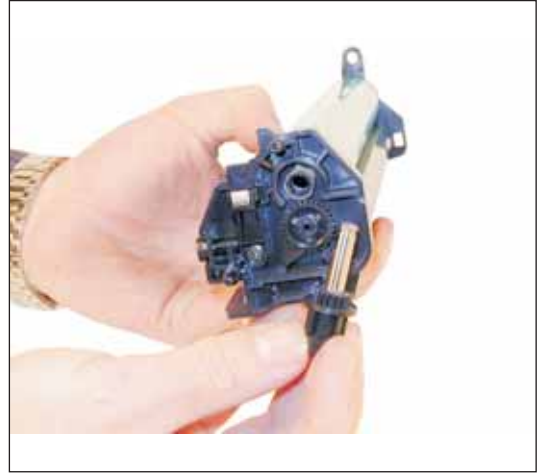
5) On the opposite side of the cartridge, pry out the drum drive gear and axle pin from the drum. Be careful not to damage the teeth when removing the gear. See Figure's 9 & 10

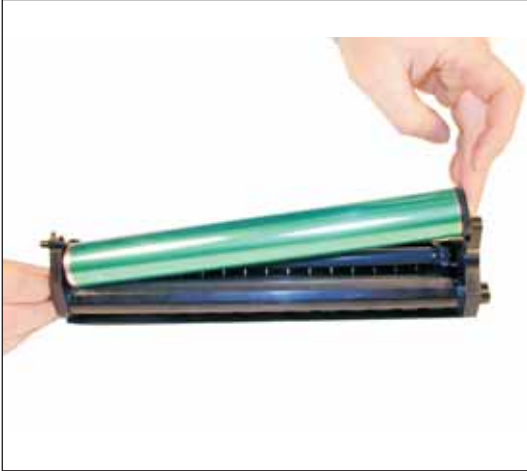
6) Remove the drum. See Figure 11

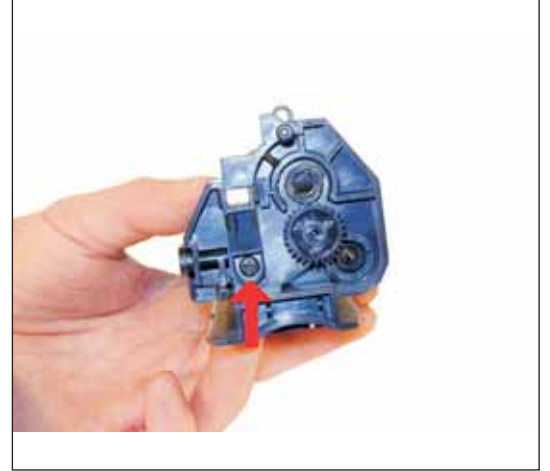
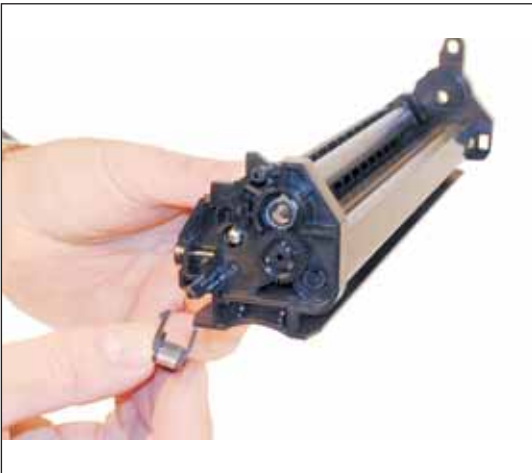
7) On the right side of the cartridge, remove the screw and contact insert. The insert can be removed by pressing in on the plastic tabs. See Figure 12 & 13

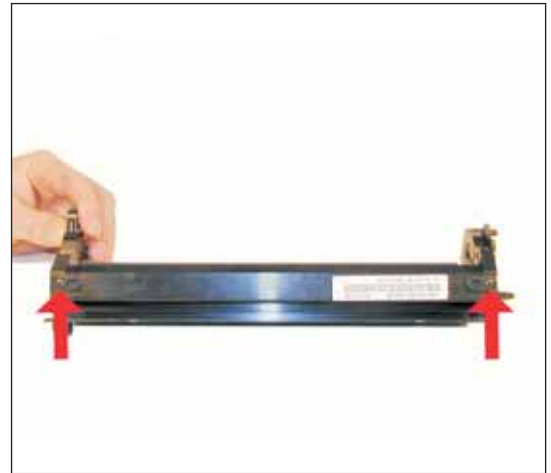
8) Remove the two screws from the PCR assembly. See Figure 14

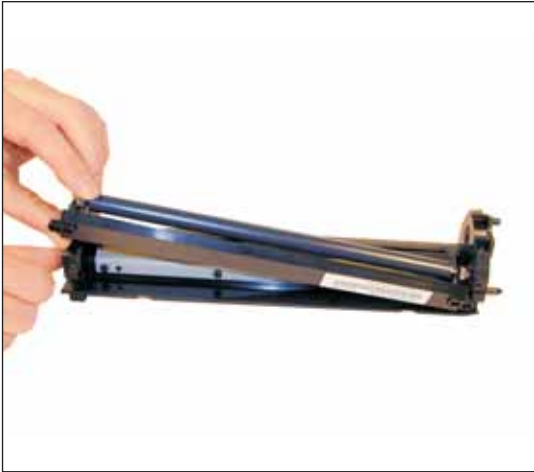
9) Press in on the PCR shaft from the right and lift the Assy. up from the left side. See Figure 15

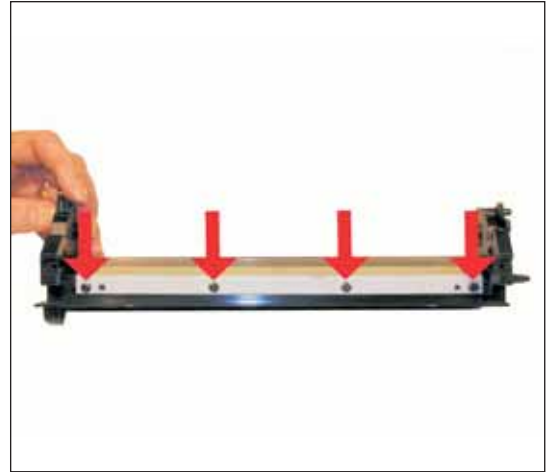
10) Remove the 4 screws from the wiper blade, and remove the blade. See Figure 16

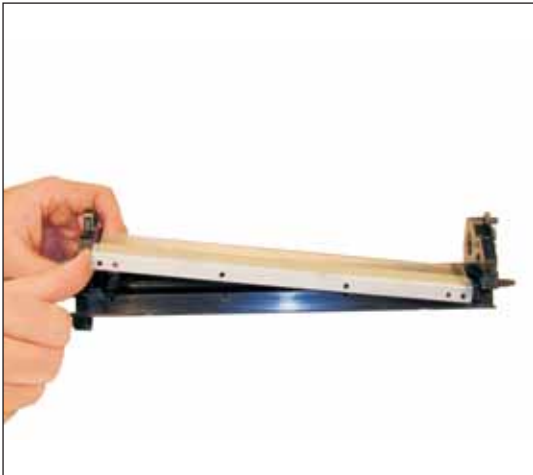
12) When new Wiper blades are available, the blade should be replaced. The OEM blades in our tests will last for one more cycle. We do not recommend that they be pushed farther than that. Install the new/cleaned wiper blade and 4 screws. See Figure 17

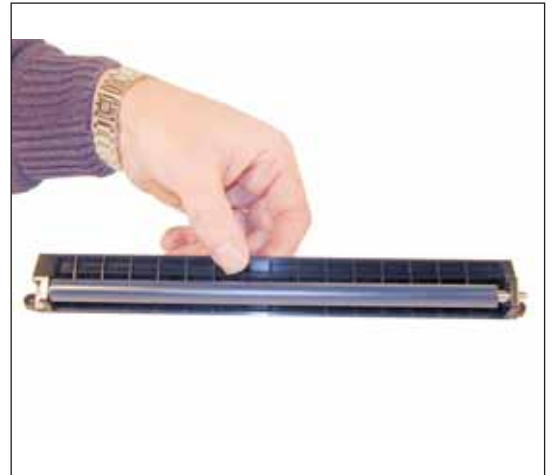
13) Clean the PCR with your normal cleaner used for Samsung cartridges. Wipe off the old conductive grease from the shaft. Re-install the PCR in the assembly. The longer bullet shaped end of the PCR is the right side. See Figure 18

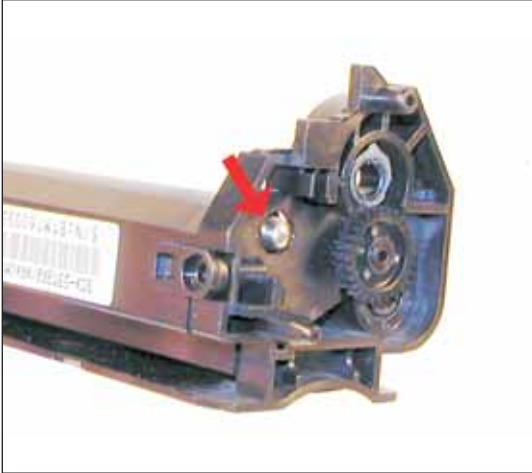
14) Install the PCR Assembly right side first. See Figure 19

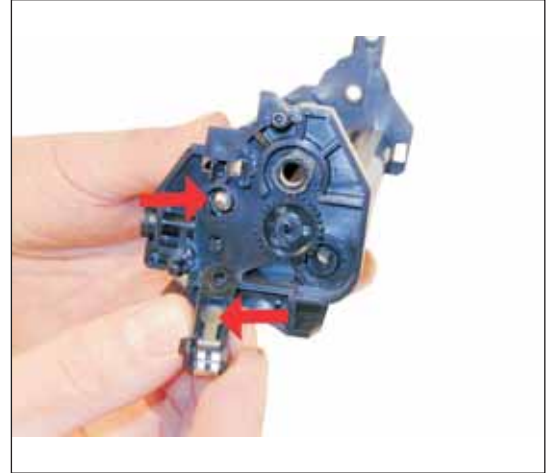
15) Place a small amount of conductive grease on the tip of the PCR shaft. Clean all the old conductive grease from the contact plate, and replace it with new grease. Install it on the cartridge, install the screw. See Figure 20

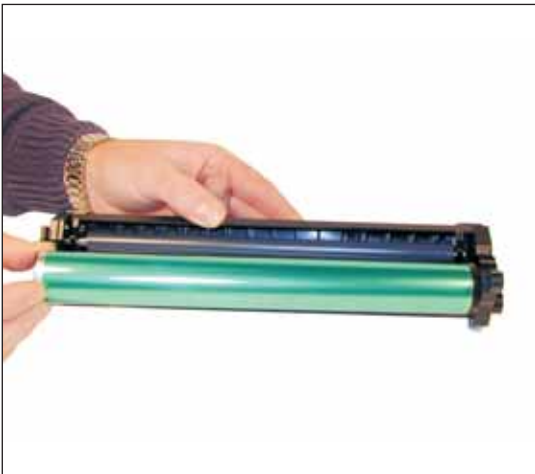
16) Install the drum gear side to the right. As with the wiper blade, the OEM drum if in good shape should run another cycle. Further than that is not a good idea. See Figure 21

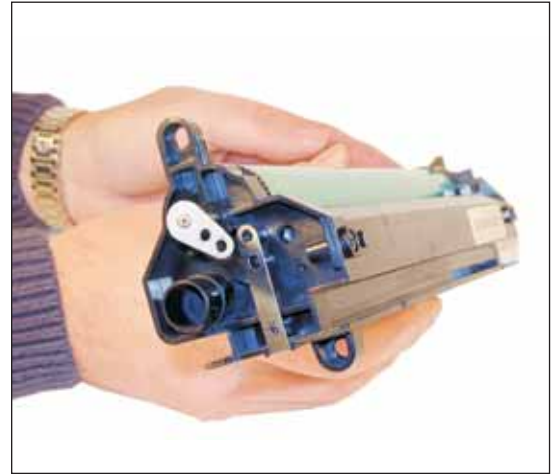
17) Clean the old conductive grease off the drum axle pin. Place new grease on the shaft, and install into the cartridge. Install the axle screw. See Figure 22

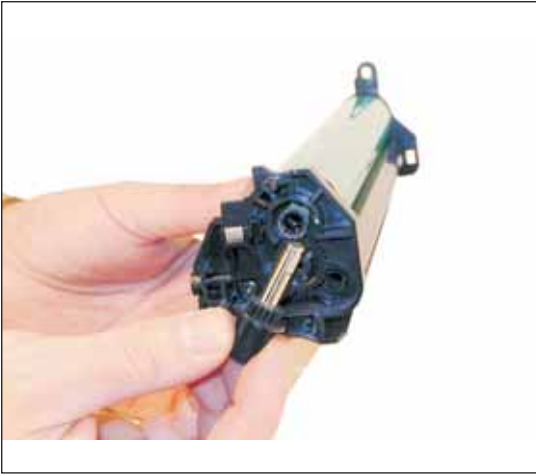
18) On the left side of the cartridge, install the drum drive gear/axle. Make sure the teeth of the gear meshes properly. See Figure 23

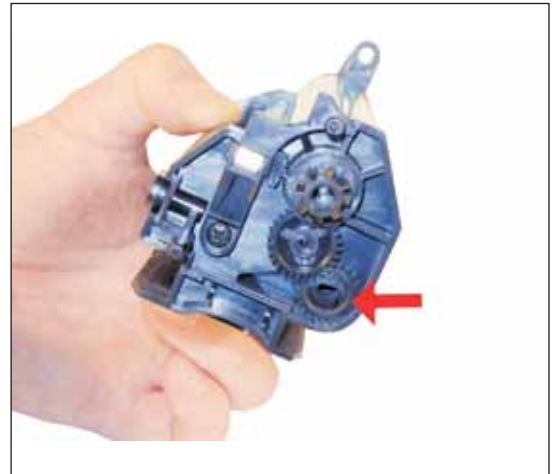
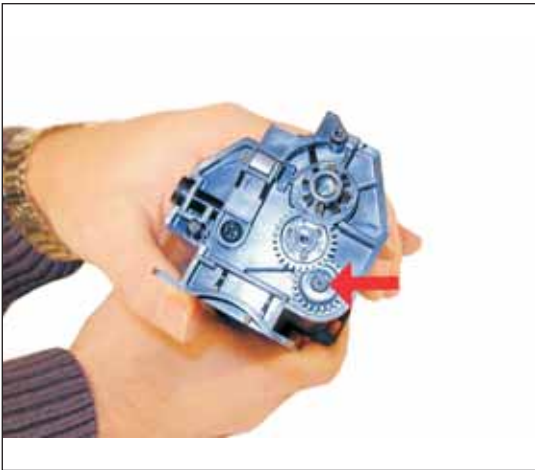
19) On the gear side, install the auger drive gear under the middle gear. Slide the auger keyed/foam seal side first. Make sure the keyed end fits into the keyed slot on the gear. See Figure's 24 & 25

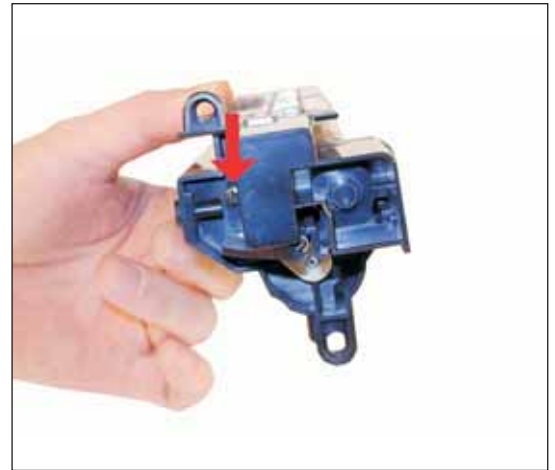
20) Install the waste chamber, and screw. See Figure 26
