DELL® 3100 CN CARTRIDGE REMANUFACTURING INSTRUCTIONS

INCLUDES CHIP REPLACEMENT PROCEDURE

DELL® 3100 CN TONER CARTRIDGE

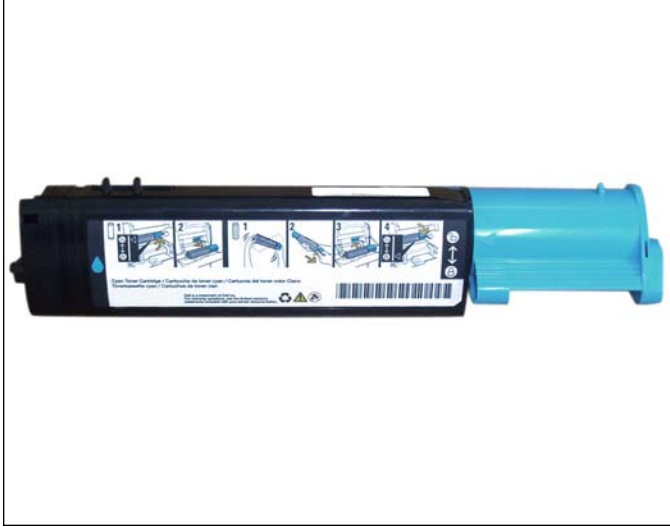
1. Disassembling the toner cartridge, starting from the lock position.

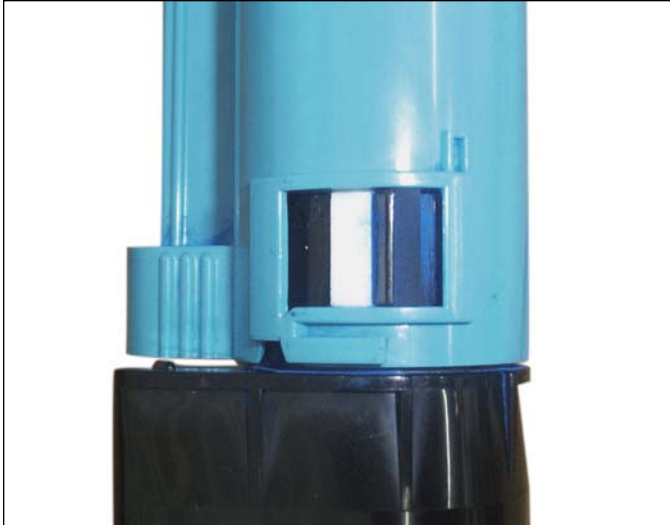
3. This is the starting point.
